EMP INSPECTION REPORT

11605 E. 12th St. - Tulsa

Inspection Date:
9/14/09

Report Number:
29092009

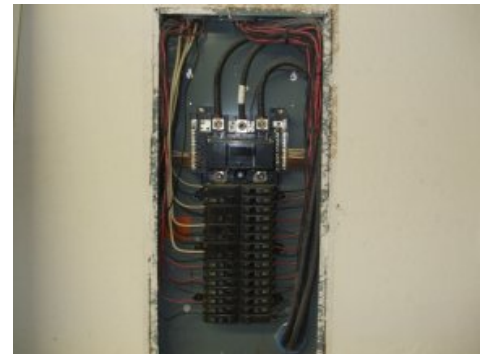
- **Improve:** A ground fault circuit interrupter (GFCI) outlet on the east wall in the garage did not respond correctly to testing during the inspection. This receptacle should be replaced.
- **Improve:** An outlet on the north wall in the kitchen has an open neutral. This outlet and the circuit should be investigated and improved as necessary.
- **Improve:** Missing outlet cover plates in the attic next to the heater should be replaced.

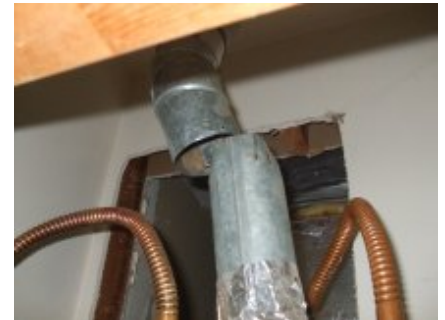
- **Safety Issue:** The water heater venting system shows evidence of exhaust “spillage”. *This is a serious condition that could be a health threat to the occupants of the home.* This condition should be addressed promptly. (see picture)
