HOME INSPECTION REPORT

117 S. 123th E. Ave. - Coweta

Inspection Date:
10/21/09

Report Number:
40102009

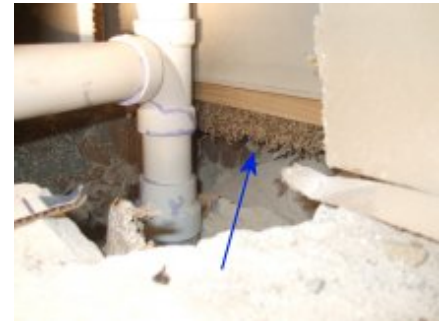
- **Major Concern:** The floor at the west wall of the master bedroom where the hole was made of the whirlpool tub should be filled with concrete under the wall and the master bedroom floor. Currently, carpet is covering the hole. The hole extends from the master bathroom, under the wall and into the master bedroom. (see picture taken from bathroom; the carpet in the picture from the master bedroom)

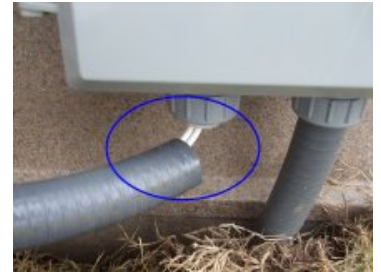
- **Improve:** The conduit for the wiring for the septic controller at the northeast corner of the house does not go into the connector leaving the wiring exposed. (see picture)

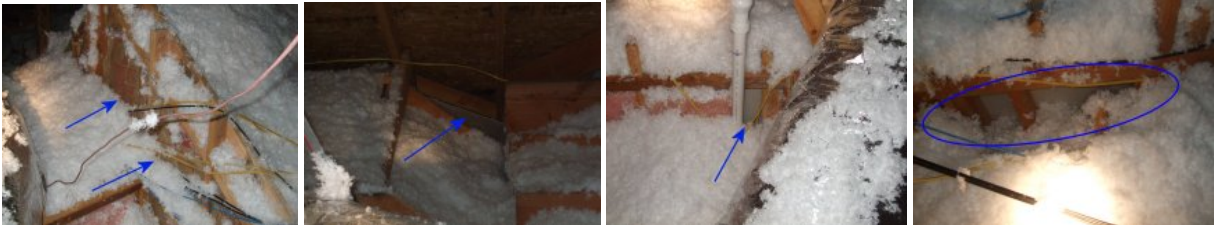
- **Improve:** The fiberglass mat insulation on the east and west kitchen addition walls in the attic is installed backwards. This condition can prevent moisture from evaporating through the insulation. The insulation should be turned over so the vapor barrier/paper on the insulation is towards the warm side of the addition wall. (see first picture)
- **Improve:** The missing insulation on the north slope of the kitchen ceiling, the southeast corner of the master bedroom, the south addition wall of the dining room and the east addition wall of the hallway should be installed. (see second picture – master bedroom ceiling, third picture – dining room addition wall, fourth picture – east addition wall of hallway)
