# HOME INSPECTION REPORT

**903 S. Lynn Ln. Rd. - Tulsa**

**Inspection Date:**  
7/20/09

**Report Number:**  
39072009

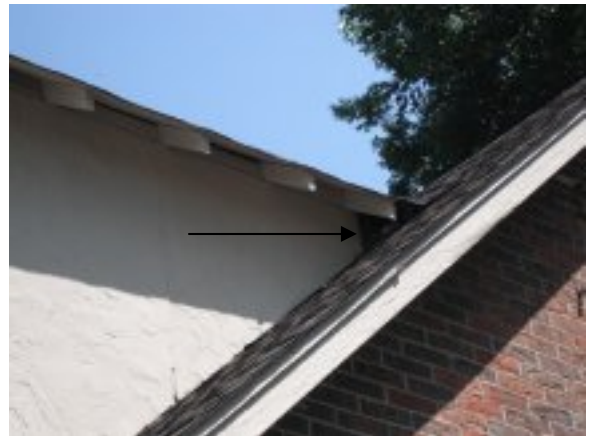
- **Improve:** The gaps in the wood siding at the south side of the house should be caulked.
- **Improve:** The missing siding at the dormer roofline at the west side of the house should be replaced.
- **Improve:** Wood/soil contact at the base of the siding at the south side of the house should be eliminated.
- **Improve:** The loose vinyl siding below the window on the east and west sides of the house, under the windows should be properly secured.
- **Improve:** Vines growing on exterior walls at the west side of the home should be kept trimmed away from siding, window trims, and the eaves.

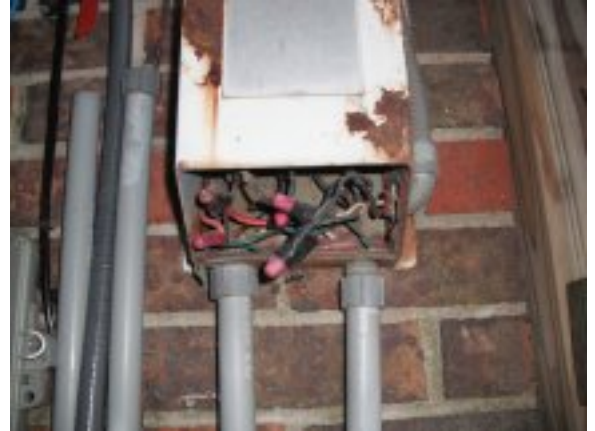
- **Safety Issue:** Improper electrical connections (spliced wiring) should be improved at the light in the family room closet. All electrical connections should be made inside junction boxes fitted with cover plates.
- **Improve:** All junction boxes at the exterior north side of the house below the meter and in the crawl space should be fitted with cover plates, in order to protect the wire connections.
- **Improve:** Loose junction boxes on the north wall in the upstairs east bedroom should be properly secured.

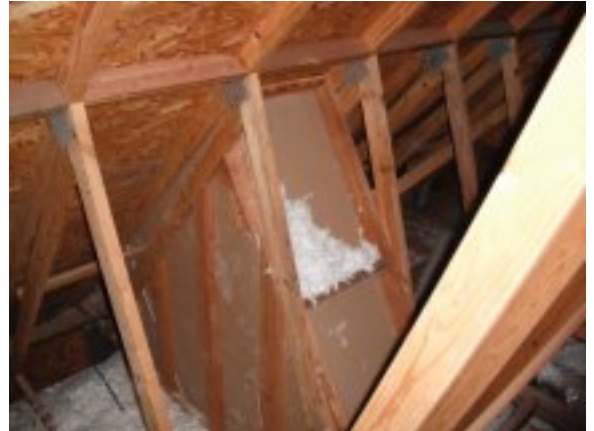
- **Improve:** The skylight walls in the attic should be insulated.
