HOME INSPECTION REPORT

34112 S. 219th St. - Bixby

Inspection Date:
11/14/09

Report Number:
17112009

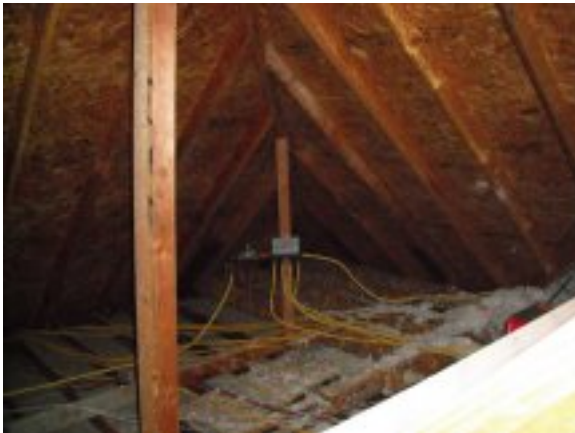
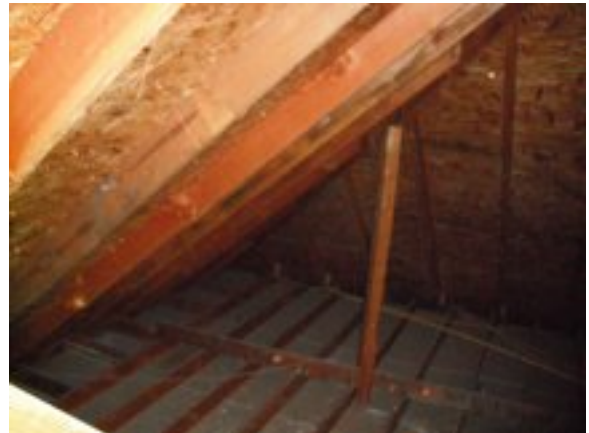
Roof Structure

- **Major Concern:** The construction of the roof structure over the garage of the home is incomplete. Perlins are needed at the south, east and west slopes of the roof structure over the garage of the home for proper framing support of the roof structure. Perlins are at least 2X6's that run perpendicular to the rafters (attached to the rafters) and have struts that run at an angle from the perlins to the ceiling joists. The perlins (the horizontal cross member that runs perpendicular to the rafters) should be supported with perlin struts (supports that extend from the perlin to the joists) every 4 – 5 feet apart and should not be any less than at a 45 degree angle. Proper roof structure support was observed on the roof structure in the north attic on the home.

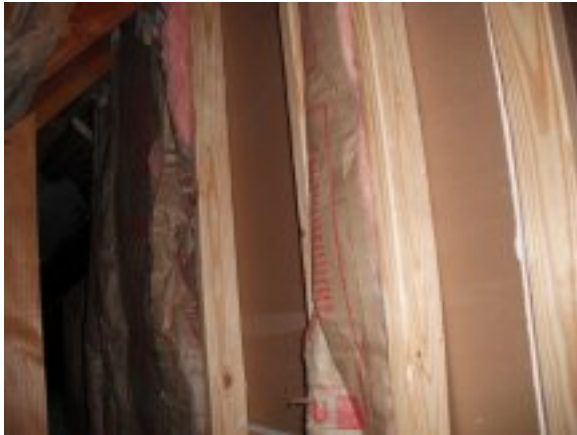
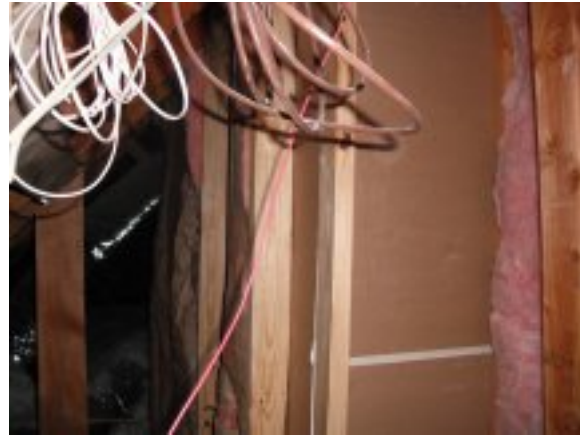
Attic / Roof

- **Improve:** Missing insulation in the east attic walls behind the upstairs bathroom should be replaced. Insulation should be installed with the vapor barrier to the warm side of the home. Some insulation installed in this area was also observed to be installed improperly. The insulation should be installed with the vapor barrier to the warm side of the home.
